StolSpeed Vortex Generators on a Harmon Rocket II – Flight Test Report

Version 1.1, November 29, 2016

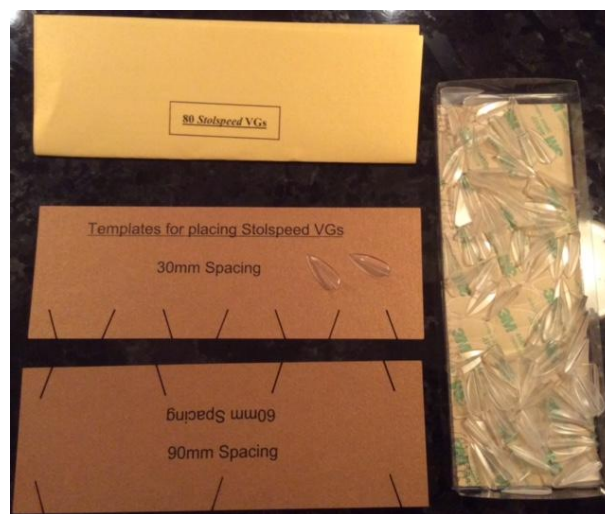
Figure 2. StolSpeed 80 Installation Kit

The VGs were purchased from Aircraft Spruce Canada as the “STOLSPEED VORTEX GENERATORS 80” kit. Installation took about two hours, following the on-line instructions provided by StolSpeed. The kit provides heavy paper installation templates, however, these have a tendency to distort during installation. In order to provide more precision during installation, it is recommended that these templates be copied onto thin, flexible plastic that will not distort with use.

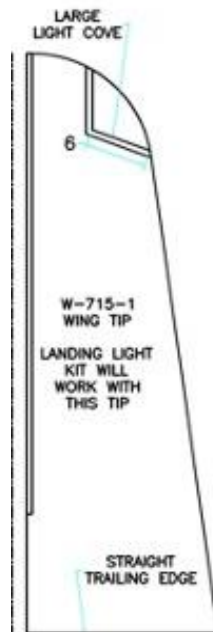
Figure 3. Vans Aircraft Wing Tip

The wingtips on C-GVRL are the W-715-1 type, with the large light cove. This prevented following the exact installation instructions which required the first VG to be installed 2 inches inboard of the wing tip. Communication with StolSpeed indicated that the first VG should be installed just inboard of the light cove.
